Technical Service Bulletin

No.LTB00055
03
May 2007

Subject/Concern:Knocking Noise From Front Suspension

Models:
Freelander 2 | | VIN- range: 7H001002-7H035242

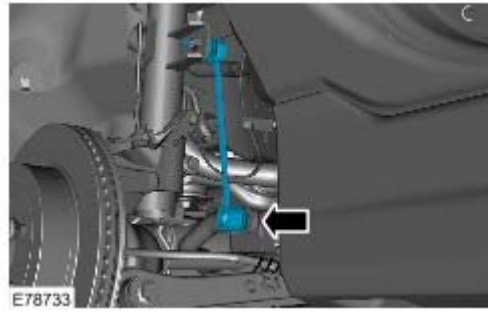
Cause: Stabilizer bar link nut loose due to excess paint in the joint.
Action: Should a customer express concern, install new nuts that secure the stabilizer bar to the stabilizer bar link. Follow the Service Instruction outlined below.

**CAUTION: Use an Allen key to prevent the stabilizer bar link rotating while removing the nut.**
Remove the nut securing the stabilizer bar to the stabilizer bar link.

Install the new nut to the stabilizer bar to the stabilizer bar link and tighten to 70Nm.
