TECHNICAL SERVICE BULLETIN

reissue No.LTB00176v4/2008

Subject/Concern:	Seat Rock Update				
Model:					
Discovery 3 / LR3	VIN Range: 474327-531559				
Discovery 4 / LR4	VIN Range: 510178-531558				
Freelander 2	VIN Range: 008861-184370				
Range Rover Sport (LS)	VIN Range: 163998-238778				
Markets:	All				
Section:	501-10				
Summary	A customer may report a concern of a clicking or knocking noise emanating from the seat base. The concern is most prevalent when the vehicle is driven at low speed or at acceleration in stop/start conditions akin to around town driving.				
	This Version has been issued for a change to the summary, Parts, Labor Time and the service instruction.				
	• Please Note the below Service Instruction should only be carried out on Gemini Seat frames only see VIN range above.				
	Suggested Customer Concern Code S15.				
	Should a Customer express concern, follow the Service Instruction outlined below.

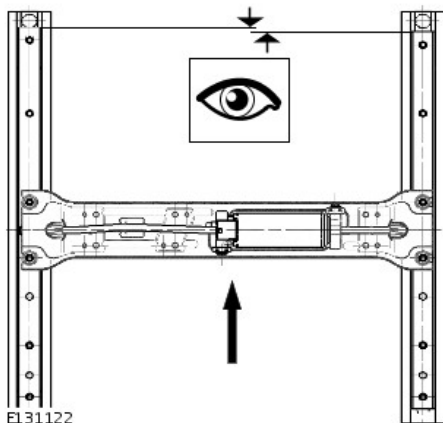
E131122

- 1. ⚠ Do not position seat all the way forward as this will prevent the seat track drive cable from being adjusted.**

On the seat to be adjusted, raise the cushion to full height and set the seat to a forward position on the seat rails.

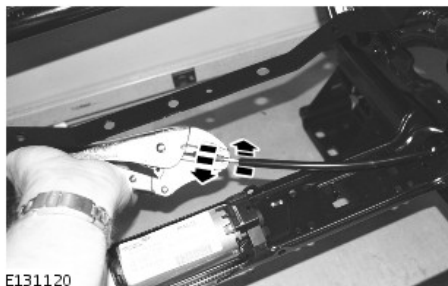
E131120

- 3. ⚠ Ensure a light grip is used as cable end is easily damaged.**

Connect a suitable pair of locking pliers to the end of the drive cable.

- 4. Turn the drive cable Clockwise 13 Full rotations.**

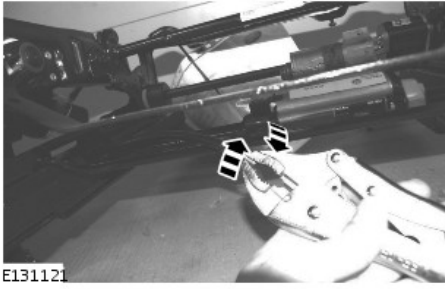
Care should be taken to ensure shaft end is inserted fully home into the seat motor shaft. Under no circumstances attempt to run motor to refit as shaft damage will result.**

Refit the seat track drive cable.
