SERVICE ACTION

Service Action Number:
Q120

Subject: MIL Lamp Illuminated and Reduced Performance	Publication No.:	309-Q120
	Model:	Freelander 2 Diesel
	Model Year:	2011
	VIN Range:	H196420 – H226884
	Date of Issue:	6 th December 2010
	Expiry Date:	31 st December 2012

RE: MIL Lamp Illuminated and Reduced Performance

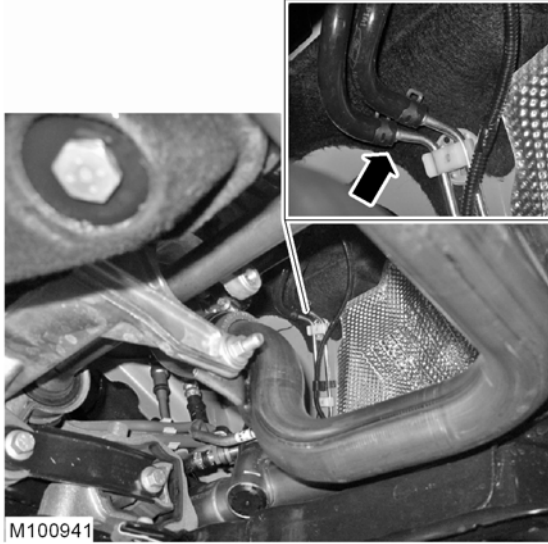
1	Raise and support vehicle (see TOPIx, Workshop Manual, section 100-02).	
2	Remove the engine under tray (see TOPIx, Workshop Manual, section 501-02).	
5	Disconnect the DPF pipe (see Fig. 1). <ul style="list-style-type: none"> Release the clip.

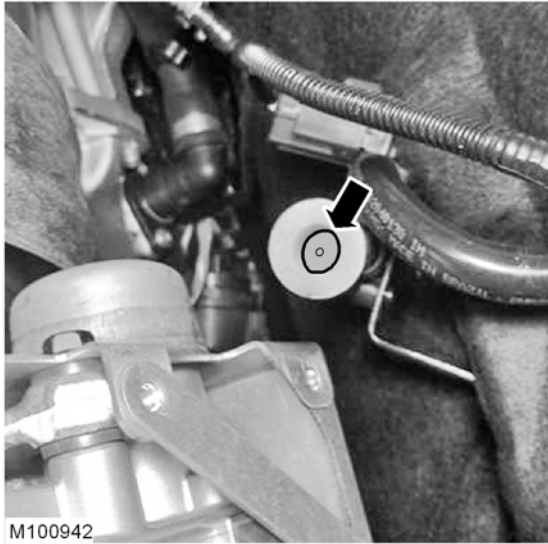
NOTE: A restrictor was fitted during manufacture between the VINs H224360 to H226884 which will need removing, but there may also be cars outside of this range but within the Service Action VIN range that may have had a restrictor fitted during service repair and will also need removing.

<p>M100941</p>
		Fig. 1
6	If fitted, using a suitable tool, remove the restrictor (see Fig. 2).
