REF NO: TJ 24643	100000000000000000000000000000000000000			CAR MARKET: United States and Canada			
3 US 7510 V	PARTNER: olvo Cars North America	YEAR	ISSUE DATE: MONTH	DAY			
FUNC GROUP: 2100	FUNC DESC: Engine	2013	05 Page 1 of 77	15

NOTE! THIS DOCUMENT SUPERSEDES TECHNICAL JOURNAL 24643 dated 2012-12-19. The TJ has been reorganized to prevent incorrect diagnosis. Part numbers have been added to the parts list for piston replacement. Checking the oil trap has been added to diagnostic process. PLEASE UPDATE YOUR FILES.

This TJ describes the measures to be taken if a customer complains about low oil level, excessive oil consumption, white smoke from the exhaust, oil smell, or the yellow warning symbol and the "Engine oil level low" text message in the Driver Information Module (DIM) on a vehicle with the Short Inline 6-cylinder (Si6) engine. The chassis range is not tied to any specific symptom or product modification and is left open-ended for this TJ since the diagnostic information is useful for all vehicles with the Si6 engine.

Volvo Car Customer Service
		TJ Instruction
		TJ No 24643
		May-13 Issue 07
Title	Excessive oil consumption, Low	v oil Level message in DIM

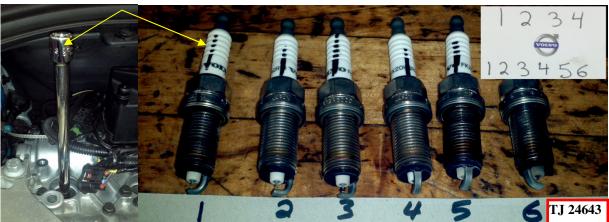
e.) Spark plug soot/ash level for Prior Approval: Level of soot/ash on plugs (0 = no soot/ash, 5 = excessive soot/ash), see Photo 1 for reference. In the example shown in Photo 1, cylinders 1-4 would have a rating of 0, cylinder 5 would have a rating of 1, and cylinder 6 would have a rating of 3. A rating of "0" would correspond to a brand new spark plug. You will be asked to provide this information and a picture of the spark plugs when submitting the online form

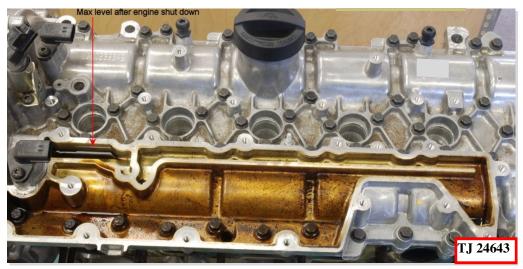
Oil in the small breather channel can be the result of multiple issues such as the engine being overfilled with oil, a defective breather box, excessive crankcase pressure or other. Oil in the small breather channel will be vented into the cylinders causing carbon/ash build-up in the cylinders starting with cylinder #6.

Photo 3. Oil in the breather channel indicating a possible PCV box (oil trap) failure

MY2011-2014 with Engine code 90: If the spark plug from cylinder #6 has more soot/ash than the others and the oil galley looks like that shown in Photo 3, then the oil trap is most likely at fault. Replace the oil trap, but still review the results from Steps 5 - 7. If the results from steps 5 - 7 are OK, then only replace the oil trap.*

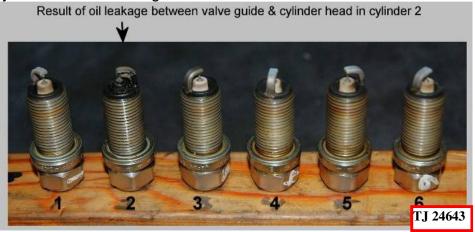
Look at the spark plugs in Photo 4 below. If the valve guide is leaking in a cylinder, the corresponding spark plug will have more soot/ash than the others. In the example in Photo 4, cylinder 2 is consuming oil.

If leakage is found on the intake or exhaust valve guides, then replace the cylinder head and add to the repair any faults found in previous steps.

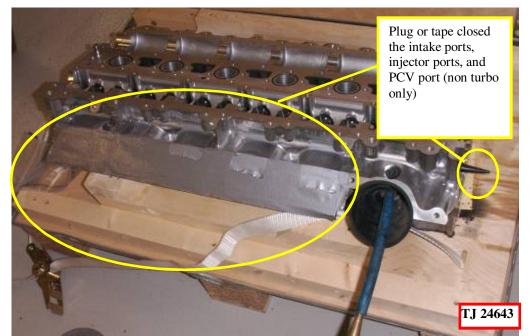
Photo 5. Note that the cylinder head is removed in this photo but this test should be performed on the vehicle.

If oil is found in the galley shown in Photo 5 on an engine code other than 90, then mention this on the prior approval form and the response from prior approval will specify what to do next.

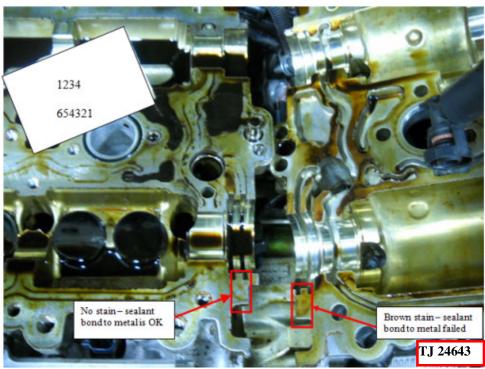
Photo 8. Check method for cam cover sealing surface. Note the placard with retailer number and chassis number is required upon submission of this photo to prior approval.

The cam cover seal was improved at engine production date 15041000001 (DDMMYYxxxxx). The production date, in this case is April 15, 2010. The engine serial number can be found using VIDA "Vehicle Details".

If the sealing surface is discolored by oil as shown in the photos, it is most likely that there is a leak between the cam cover and the cylinder head. If this is the case, reseal the cam cover and add to the repair any faults found in previous steps. Be sure to check the expiration date of the sealant bottle before use.

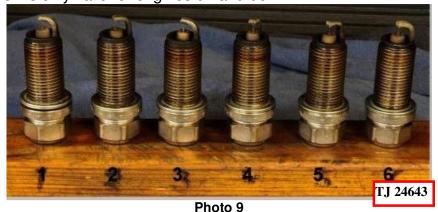
A new piston and oil control ring were introduced into production at engine date 301011B21530 (DDMMYYxxxxx). Follow the steps below for the service solution for engines built up to this date.

A new piston kit has been created to be used as a service fix. The new piston kit uses a new oil control ring which will not fit in the original piston ring land. Replace the pistons and piston rings according to VIDA and add to the repair any faults found in previous steps.
