VOLVO CAR MI

One of the most common and discussed problems with Volvo cars built on the P3 platform is, perhaps, the behavior of the automatic transmission TF-80SC / SD. The most common complaints are jerks when shifting gears, strokes when the D mode of the selector of the automatic transmission is activated, a jerk at the beginning of the movement after the activation of the "auto-neutral". All these malfunctions, mainly, are manifested at high temperatures. They began to appear after the release of the second generation of this transmission, starting from 20 weeks of 2010. The manufacturer has developed a technical solution to eliminate such problems - this is the updating of the TCM module software and the adaptation of the transmission. But, unfortunately, as practice has shown, this decision is not always enough ...

So: the patient is Volvo XC60 2013. The mileage is 63 thousand km. The problem: hard mode D selector automatic transmission after traffic in traffic jams and in hot weather and a blow at the beginning of traffic after the shutdown of "auto-neutral".

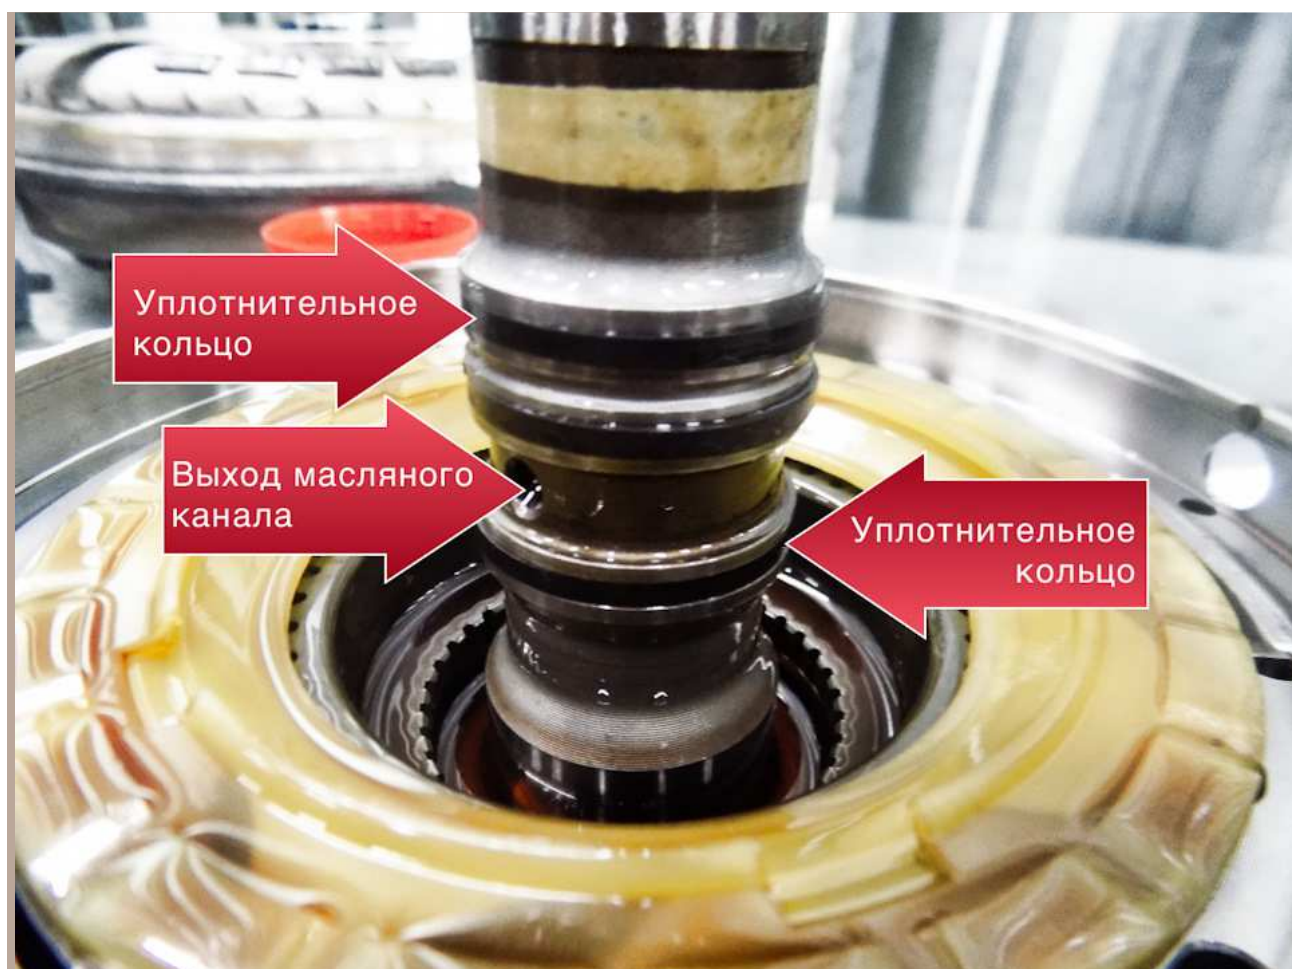
Oil leakage, according to information from VCR engineers, occurs through the joint of the shaft seal rings of the C1 clutch pack. The shaft itself is hollow, it is the main oil channel.

Here it is - the shaft of planetary gear and a package of clutches C1:

planetary shaft and clutch pack C1

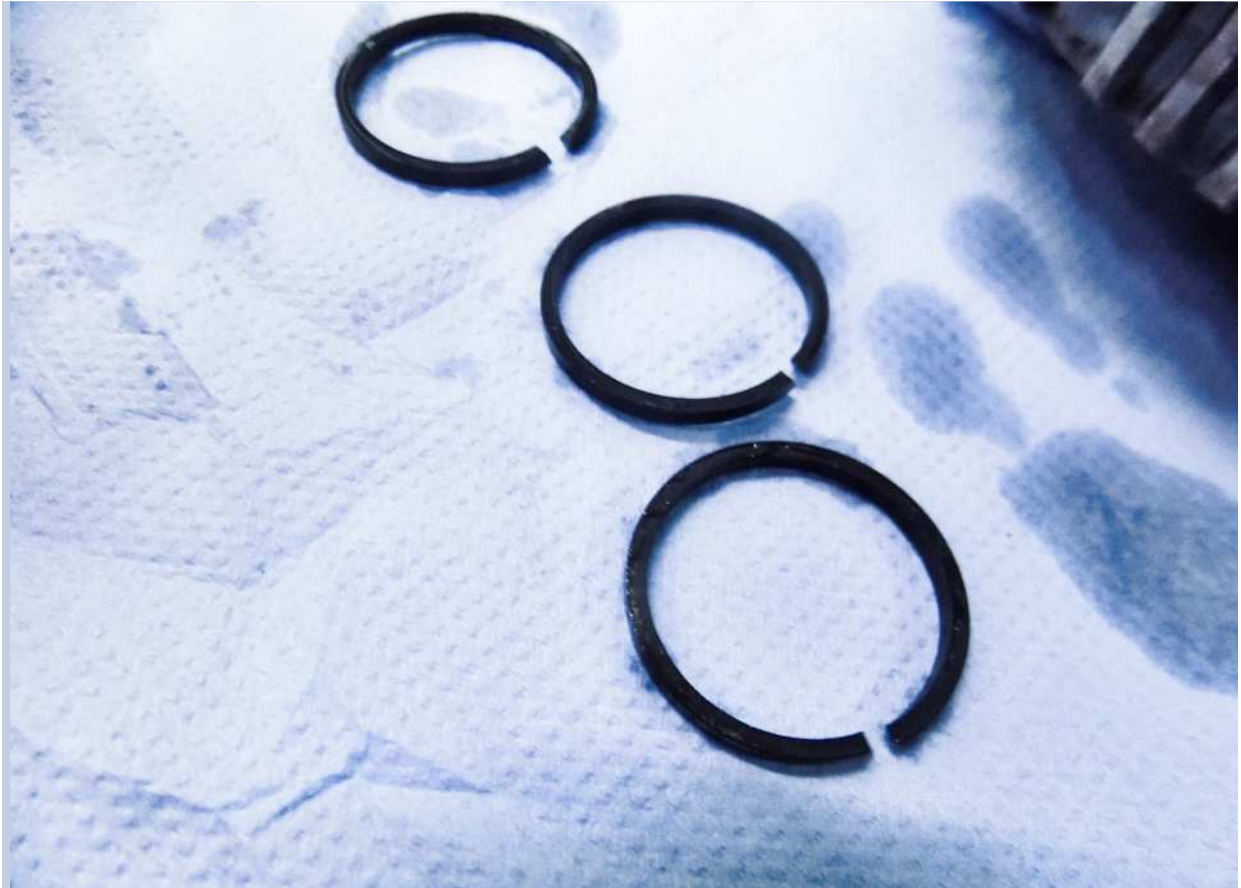
If you remove the O-rings, they look like this:

O-rings

Rings, by the way, plastic, with Teflon coating. Obviously, if there is wear, or if the size tolerance is exceeded, a leakage of oil will occur through the joint of the rings.

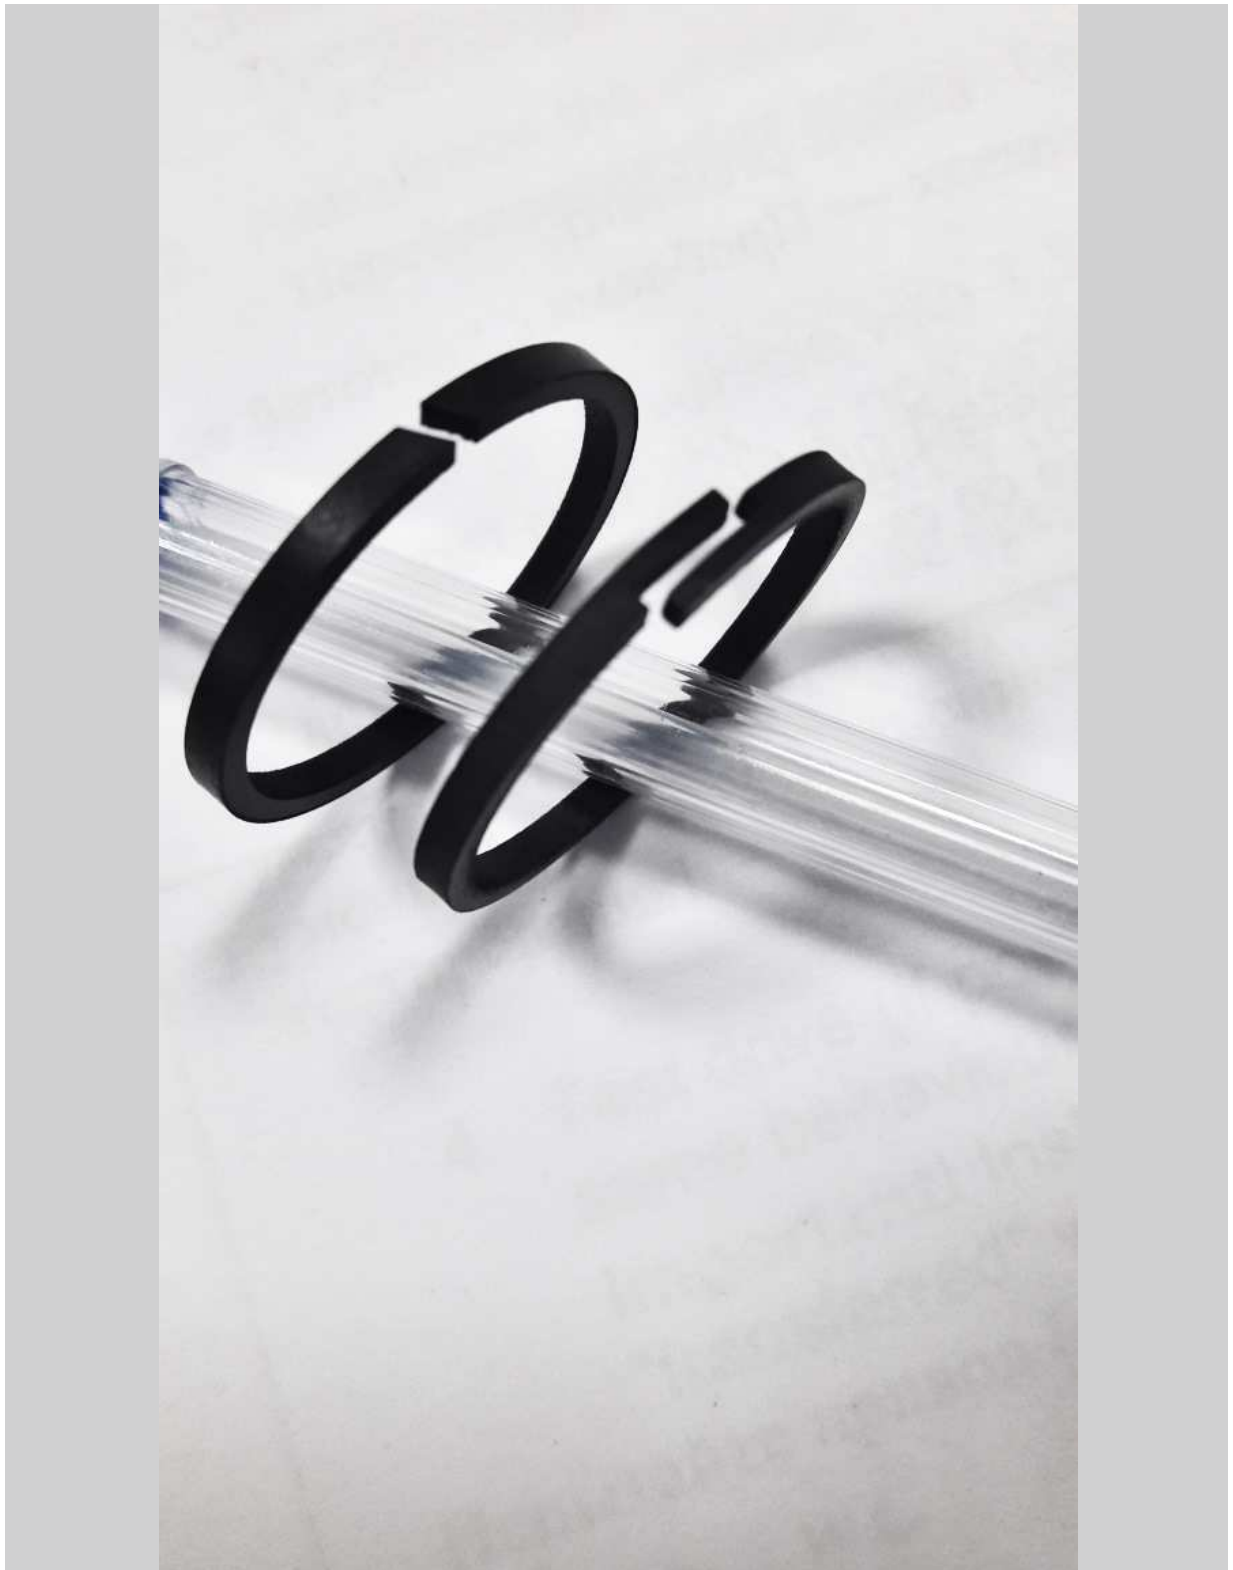
Engineers Aisin have developed a technical solution to the leakage problem - a ring with a new lock. They are introduced into production at the plant from 39 weeks of 2015.

To the left is a ring of the old model, to the right - a new one, with a labyrinth seal.

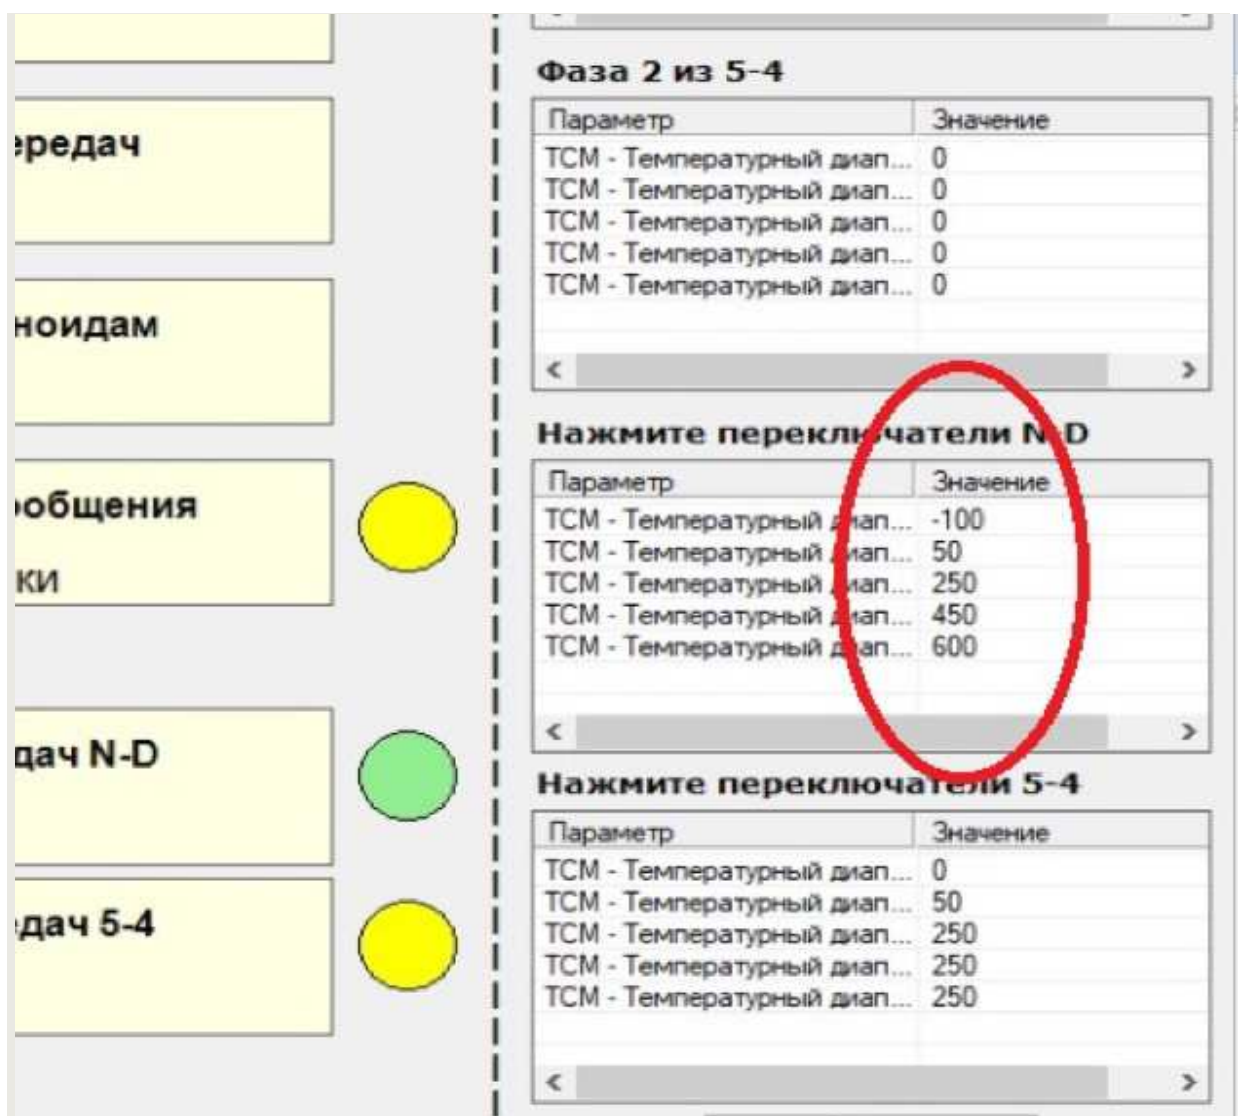
Here are the results of adaptation:

Here you can see: the spread of the coefficients is quite large. This, indirectly, indicates a significant leakage, increasing with increasing temperature.

Also, the results of a laboratory study of the viscosity of the oil at different temperatures have proved to us that the spread of the adaptation values directly characterizes the amount of uncontrolled leakage and is the basis for recommending the repair under consideration here.

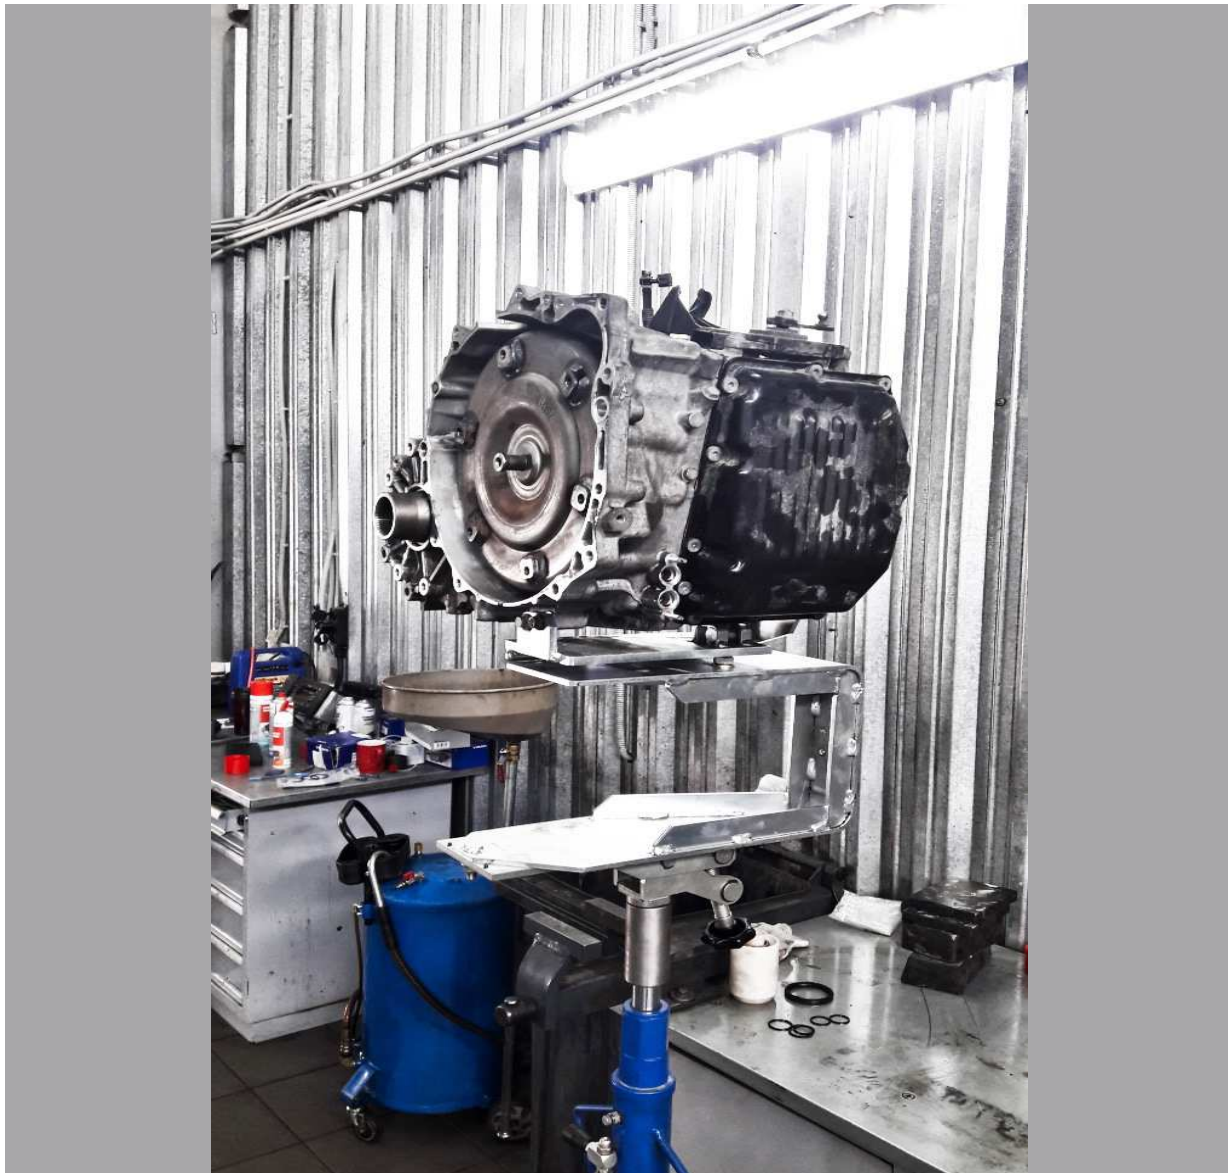
To repair the automatic gearbox we remove from the car:

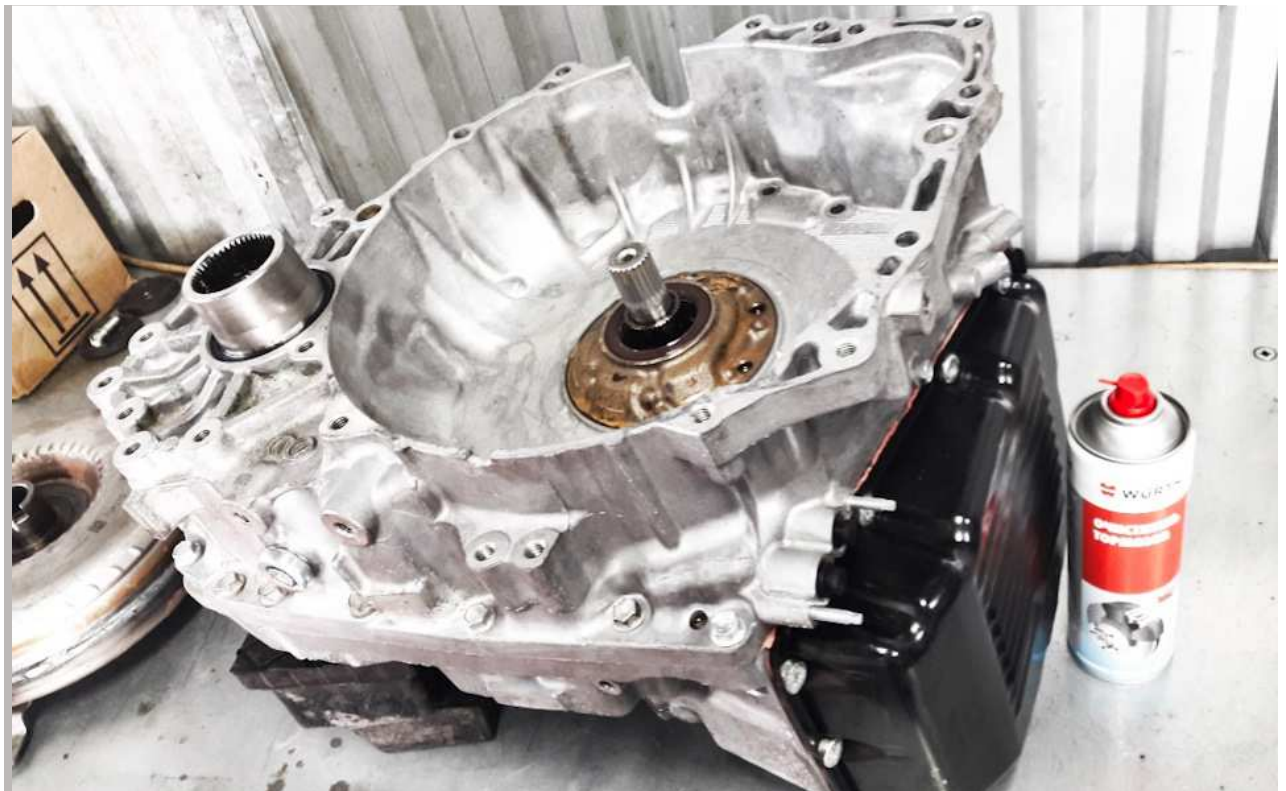
Here it is, with the converter removed:

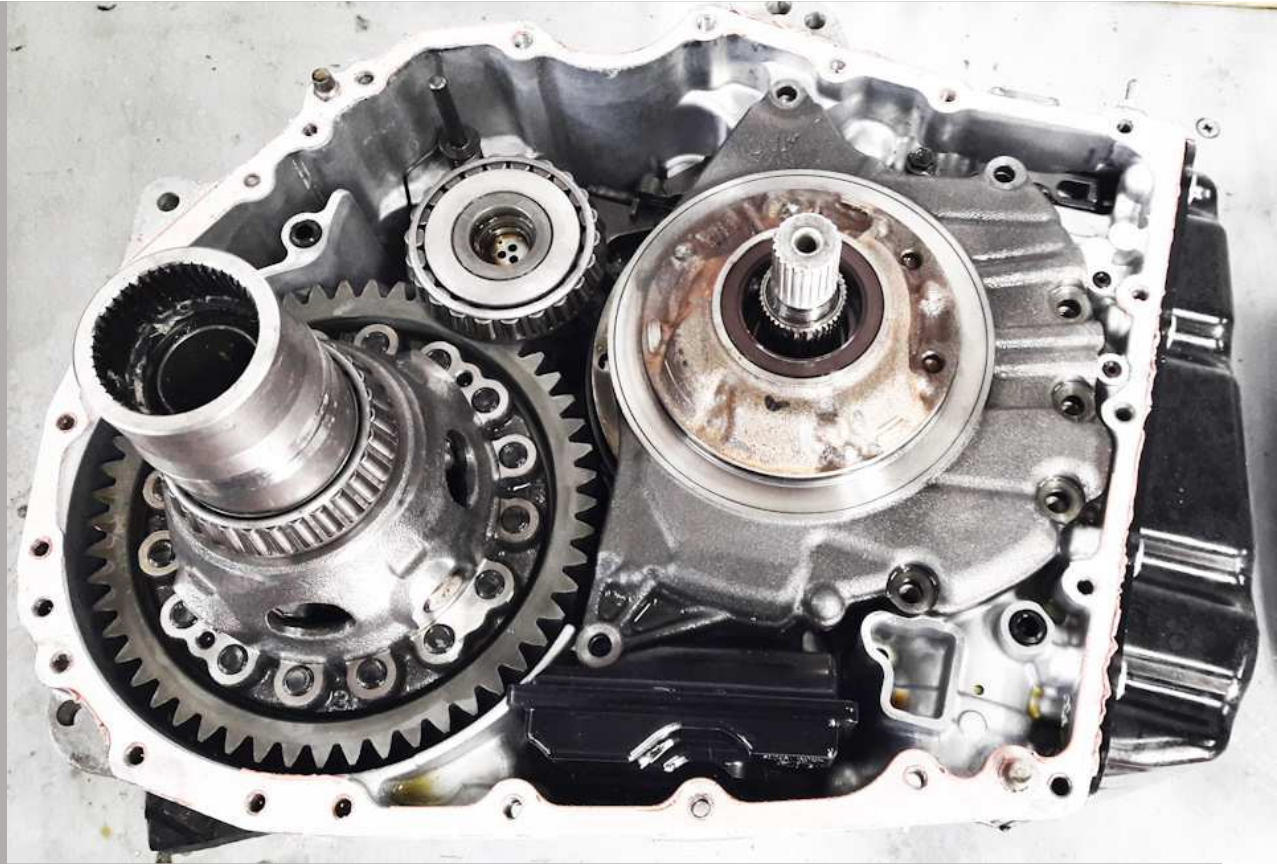
Then we divide the body of the automatic transmission and gain access to internal organs:

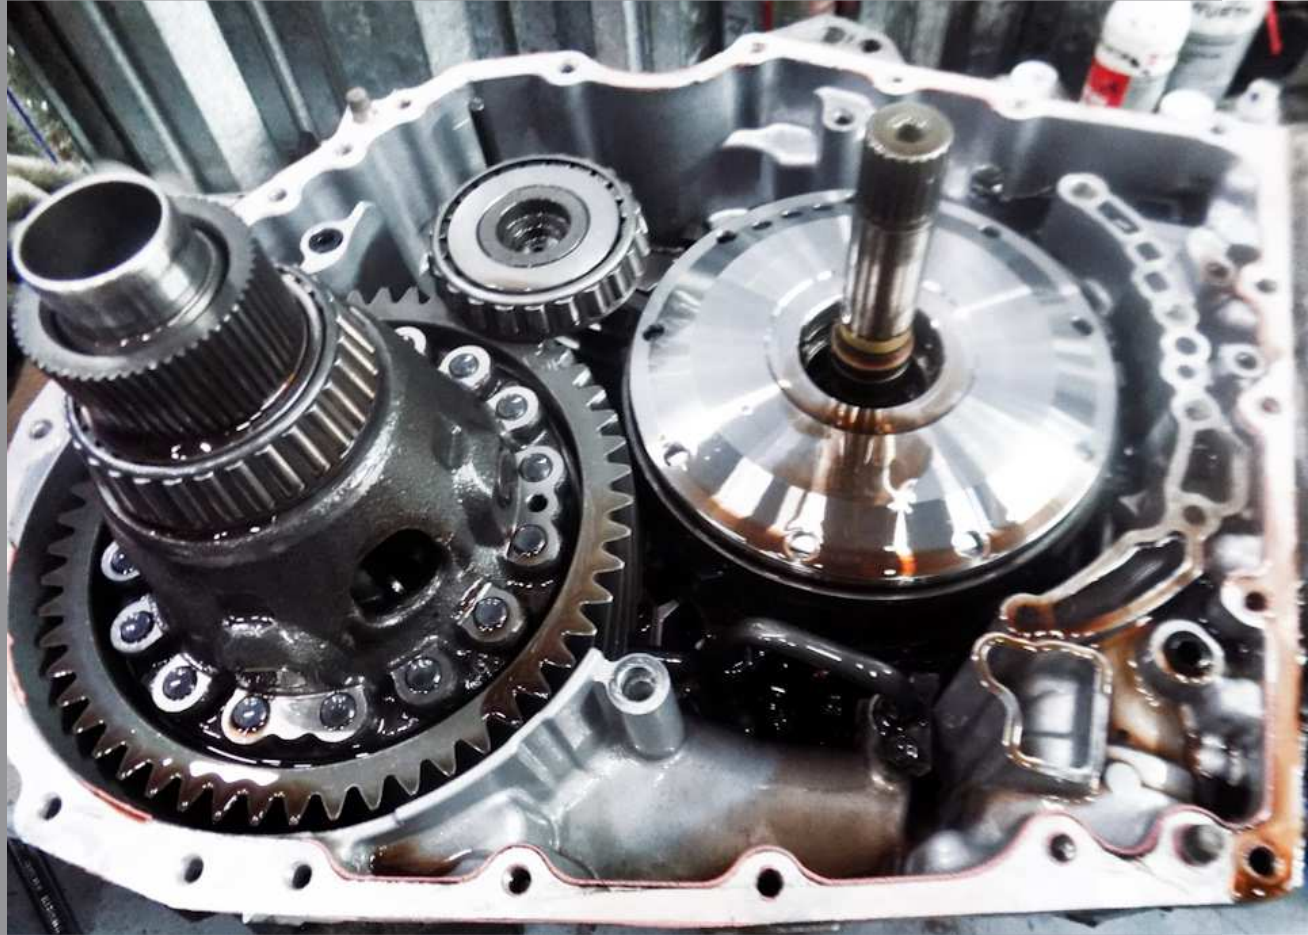
Then we remove the oil pump:

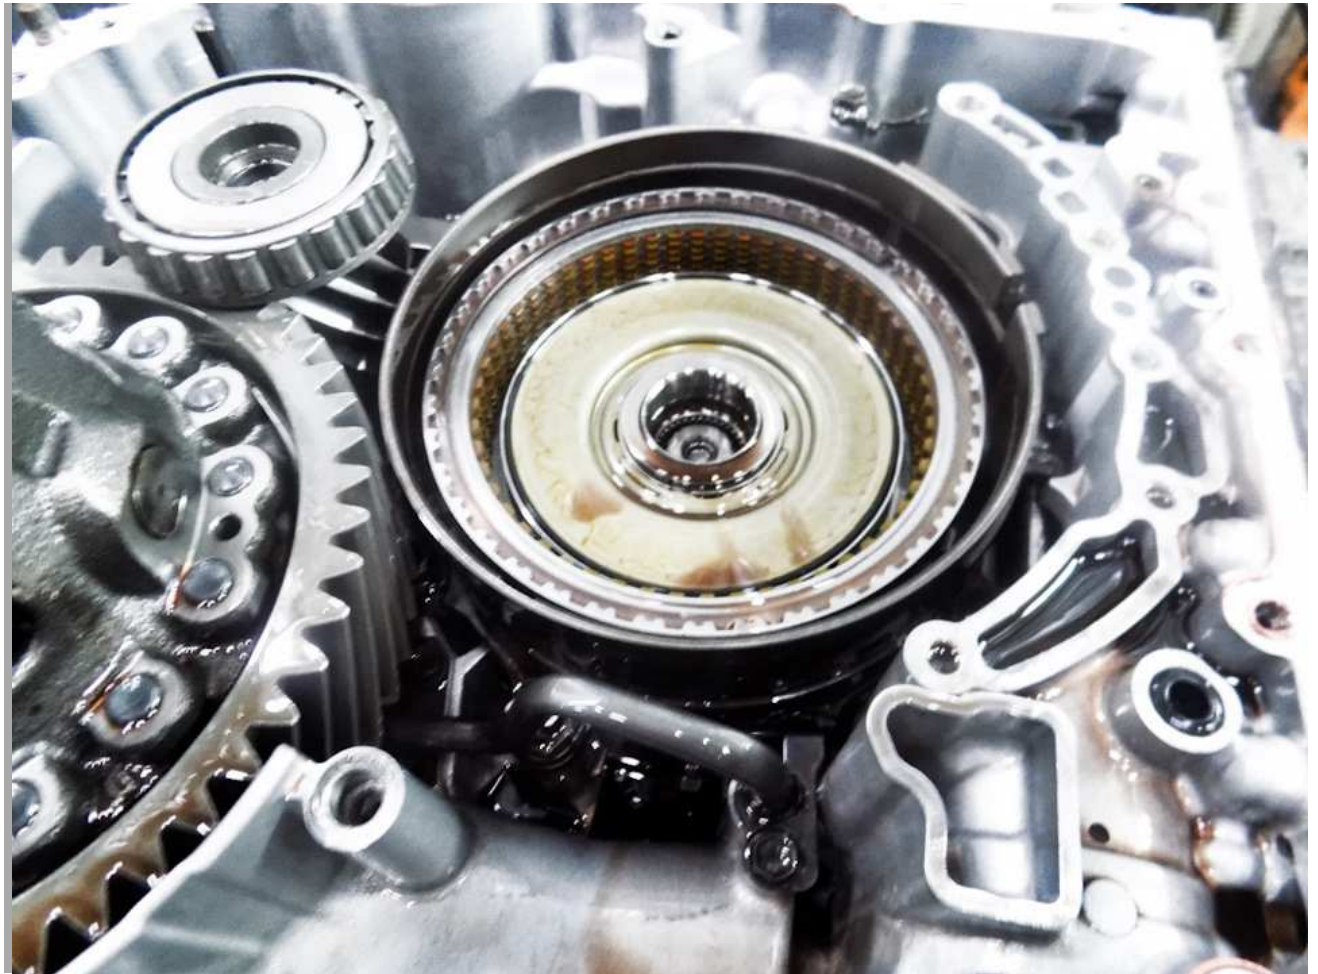
Now we have access to the planetary gear and clutch package C1 ...
Let's begin its analysis:

We extract the planetary gear. Everything, a shaft with all five seals is available!

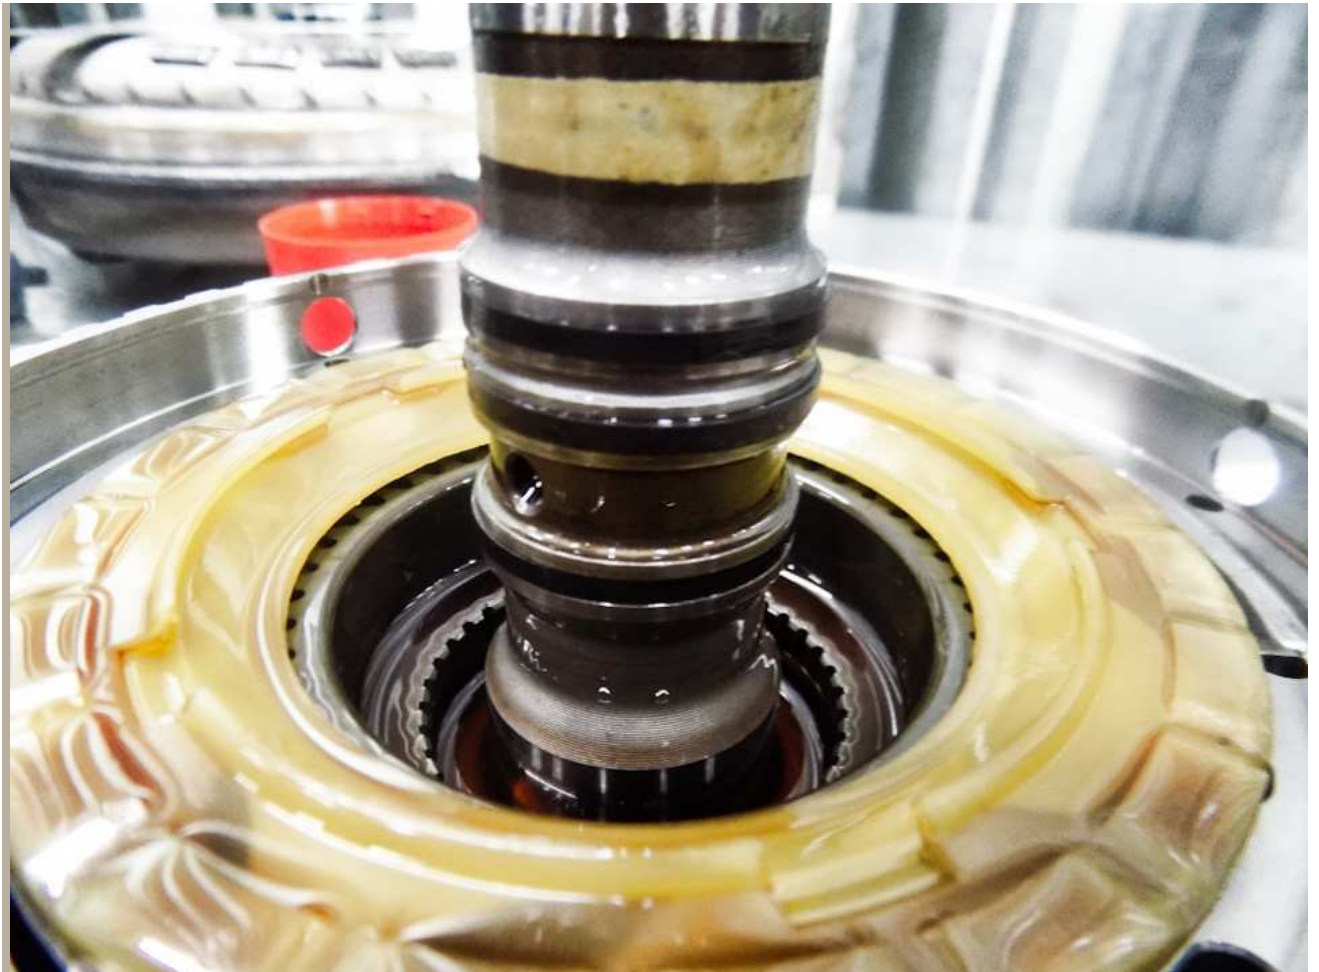
We change three rings from above:

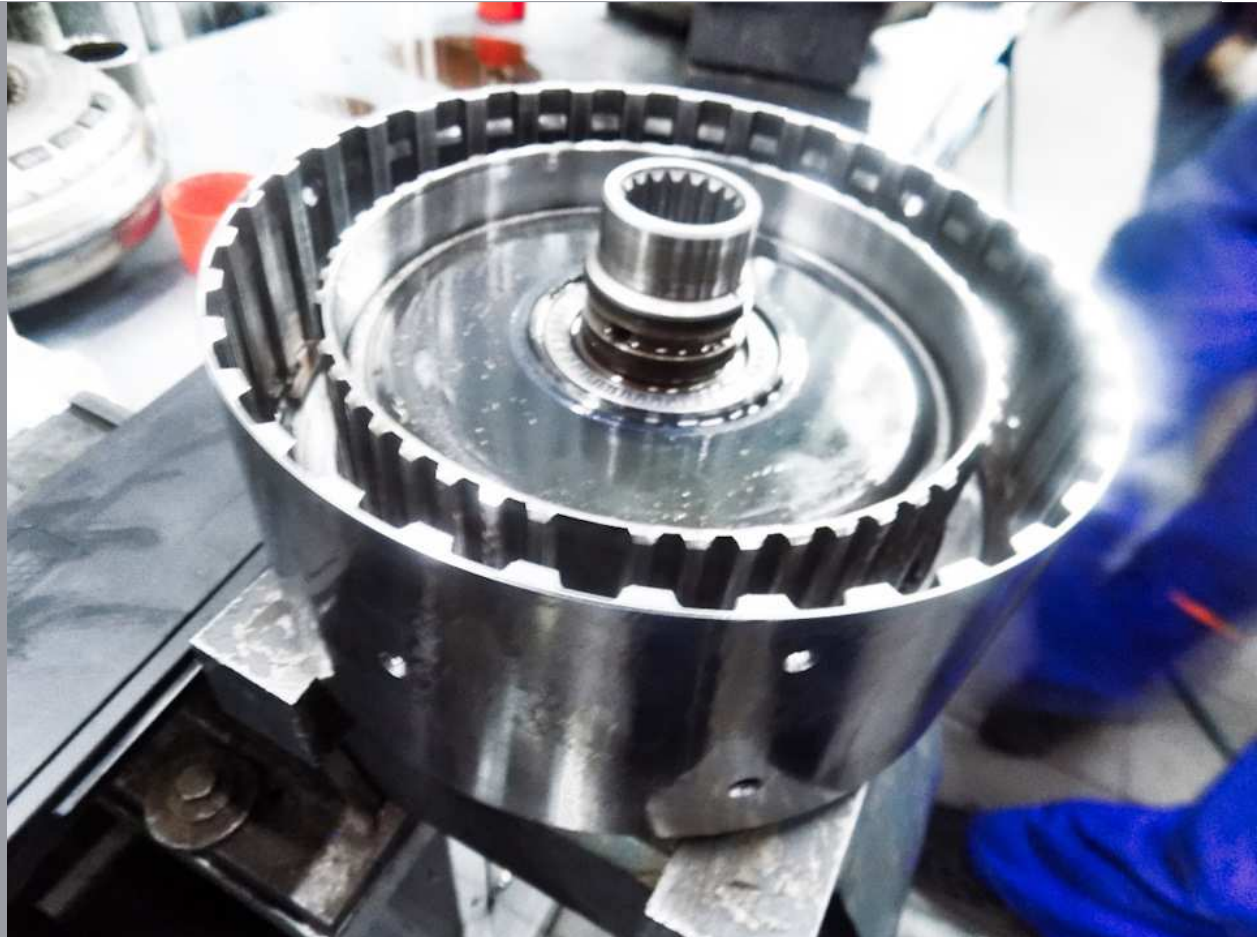
And two at the bottom:

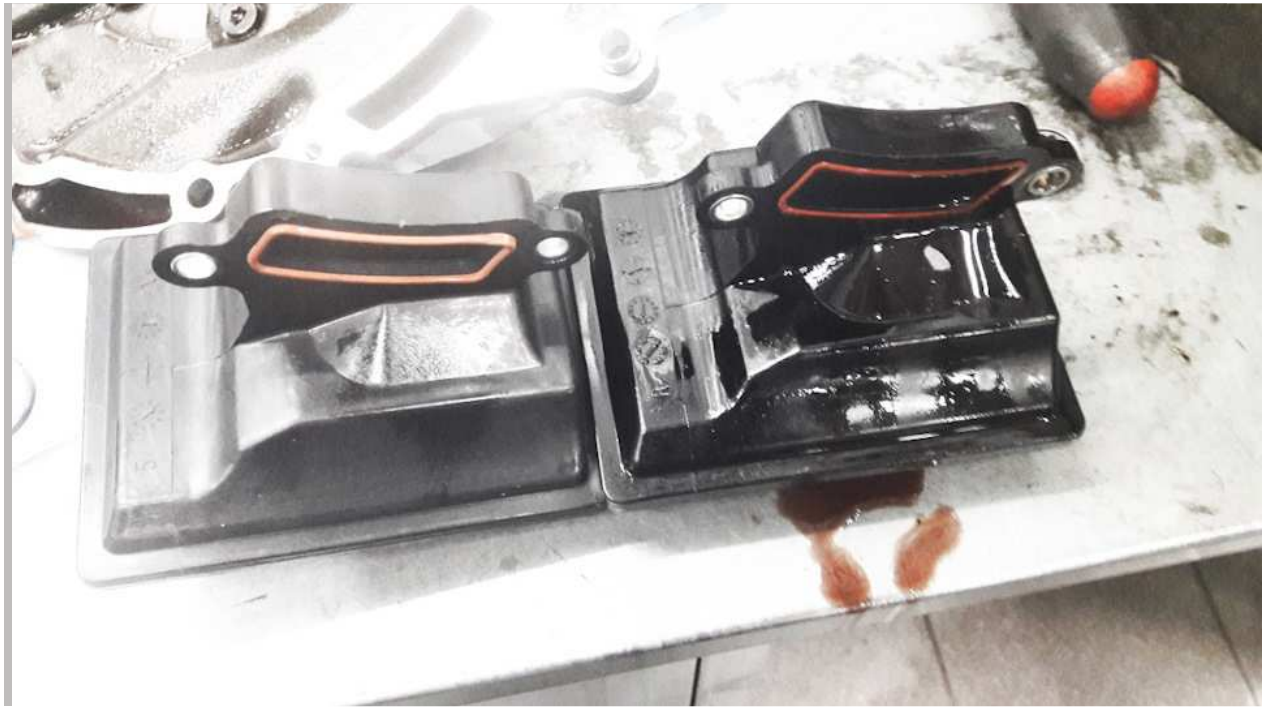
We also replaced the oil filter of the automatic transmission (it is installed on the oil pump)

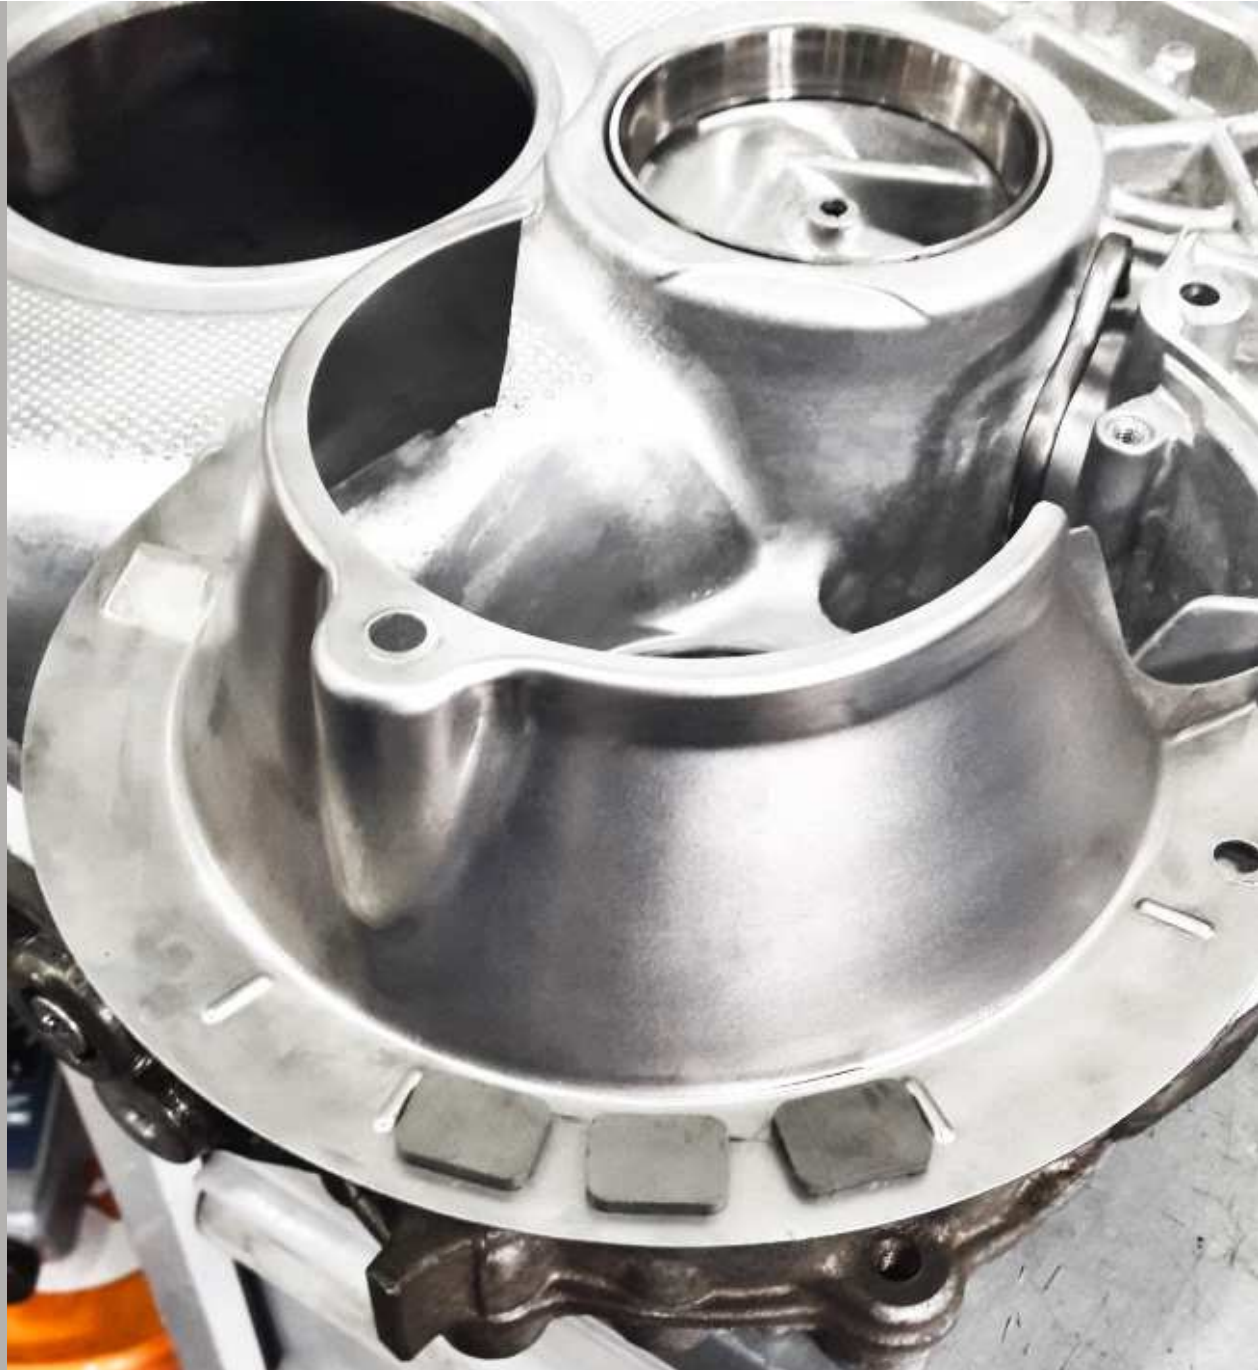
And cleaned the magnets of the wear products:

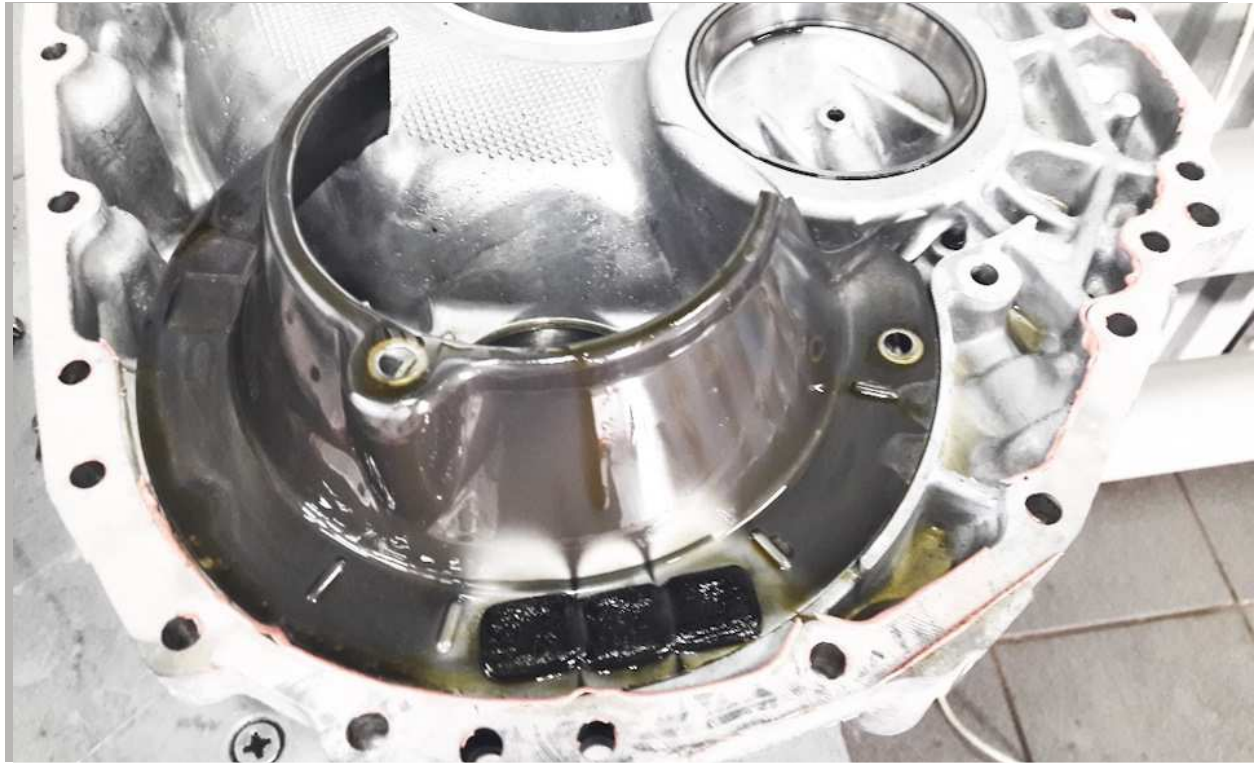
And this is a photo of the magnets BEFORE cleaning. A lot of wear products accumulate on the entire casing.
