REF NO: TJ 24643	100000000000000000000000000000000000000			CAR MARKET: United States and Canada			
3 US 7510 V	PARTNER: olvo Cars North America	YEAR	ISSUE DATE: MONTH	DAY			
FUNC GROUP: 2100	FUNC DESC: Engine	2013	05 Page 1 of 77	15

NOTE! THIS DOCUMENT SUPERSEDES TECHNICAL JOURNAL 24643 dated 2012-12-19. The TJ has been reorganized to prevent incorrect diagnosis. Part numbers have been added to the parts list for piston replacement. Checking the oil trap has been added to diagnostic process. PLEASE UPDATE YOUR FILES.

This TJ describes the measures to be taken if a customer complains about low oil level, excessive oil consumption, white smoke from the exhaust, oil smell, or the yellow warning symbol and the "Engine oil level low" text message in the Driver Information Module (DIM) on a vehicle with the Short Inline 6-cylinder (Si6) engine. The chassis range is not tied to any specific symptom or product modification and is left open-ended for this TJ since the diagnostic information is useful for all vehicles with the Si6 engine.

Volvo Car Customer Service
		TJ Instruction
		TJ No 24643
		May-13 Issue 07
Title	Excessive oil consumption, Low	v oil Level message in DIM

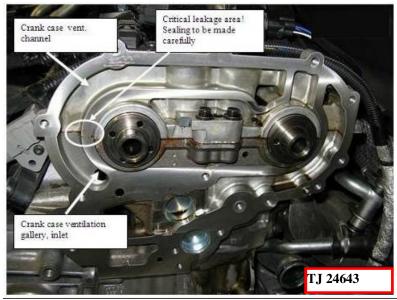
Photo 7. For reference only, not a valid check

If spark plugs in cylinder 6 & 5 have more soot than the other plugs and the engine is built before engine production date 15041000001 (DDMMYYxxxxx), then remove the cam cover and inspect the sealing surface. Refer to Photos 7 and 8 below.

The cam cover seal was improved at engine production date 15041000001 (DDMMYYxxxxx). The production date, in this case is April 15, 2010. The engine serial number can be found using VIDA "Vehicle Details".

If the discolored sealing surface is found on engines built after the engine production date, please inform the Prior Approval Department when you contact them for claim approval. Make sure you have the engine serial number when contacting prior approval.

If the sealing surface is discolored by oil as shown in the photos, it is most likely that there is a leak between the cam cover and the cylinder head. If this is the case, reseal the cam cover and add to the repair any faults found in previous steps. Be sure to check the expiration date of the sealant bottle before use.

If the sealing surface is not discolored by oil as shown in the photos, continue diagnosis elsewhere in the engine, by rechecking the previous steps. If another repair requires the removal of the cam cover, the cam cover should be resealed according to VIDA prior to re-installation, as long as the same cam cover and cylinder head will be re-installed.
