Connector: C12C

Description: Main harness to engine compartment harness

Harness: MAIN FLOOR HARNESS

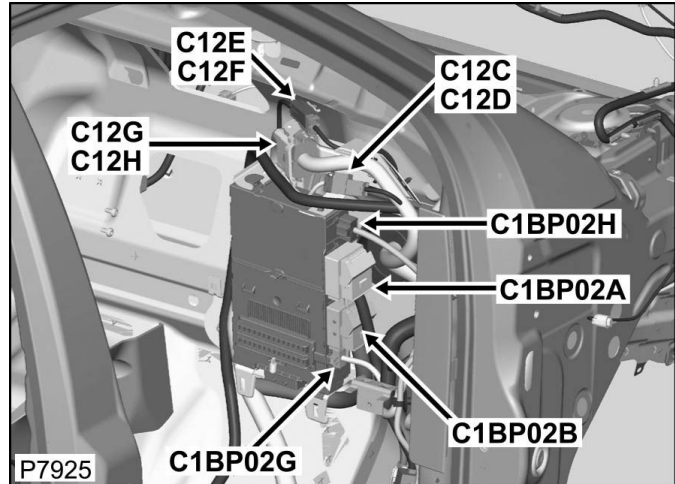
Location: Behind glove compartment

Part No.: YPC909020

Colour: BLACK

Cavities: 2WY

CAV	TERMINAL	CSA	COL	CCT	DESTN
1	YPJ900570	6.0	BU-RD	BASE	S/JOINT S3BB19
2	YPJ900570	6.0	GN-RD	BASE	S/JOINT S4BB20
