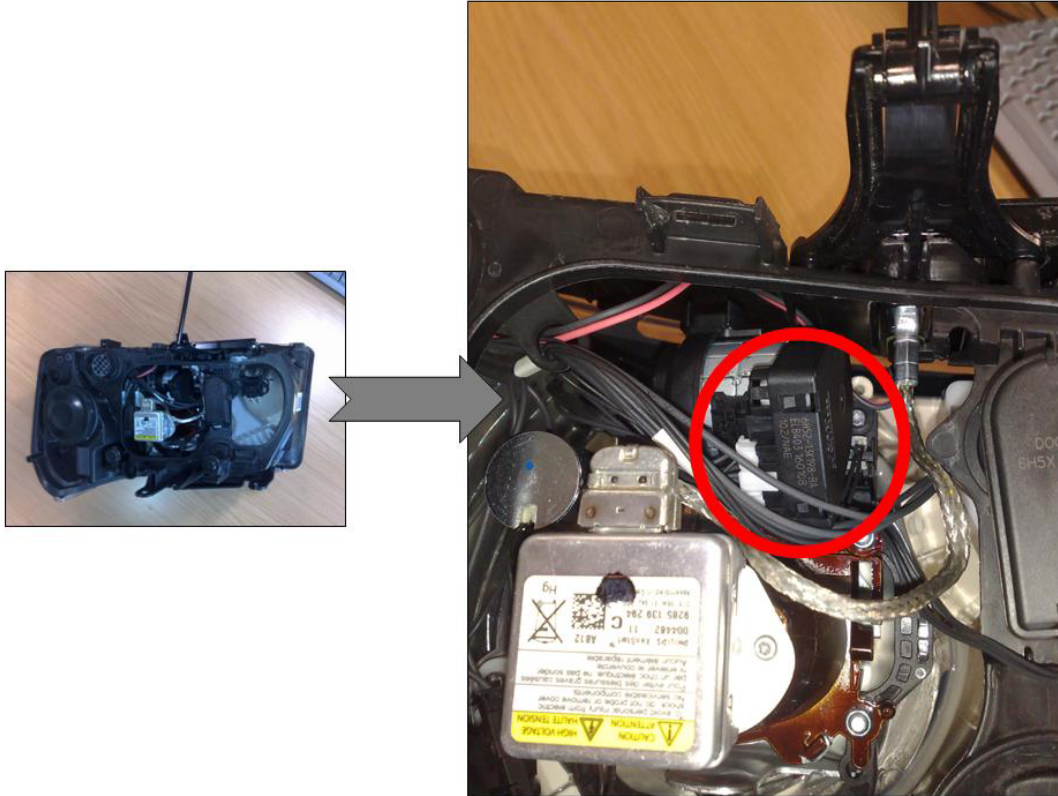
- Remove the headlamps from the car
- Unclip the locking lever, press down the two tabs and remove the cover
- Locate the AFS stepper motor as per Figure 1 below

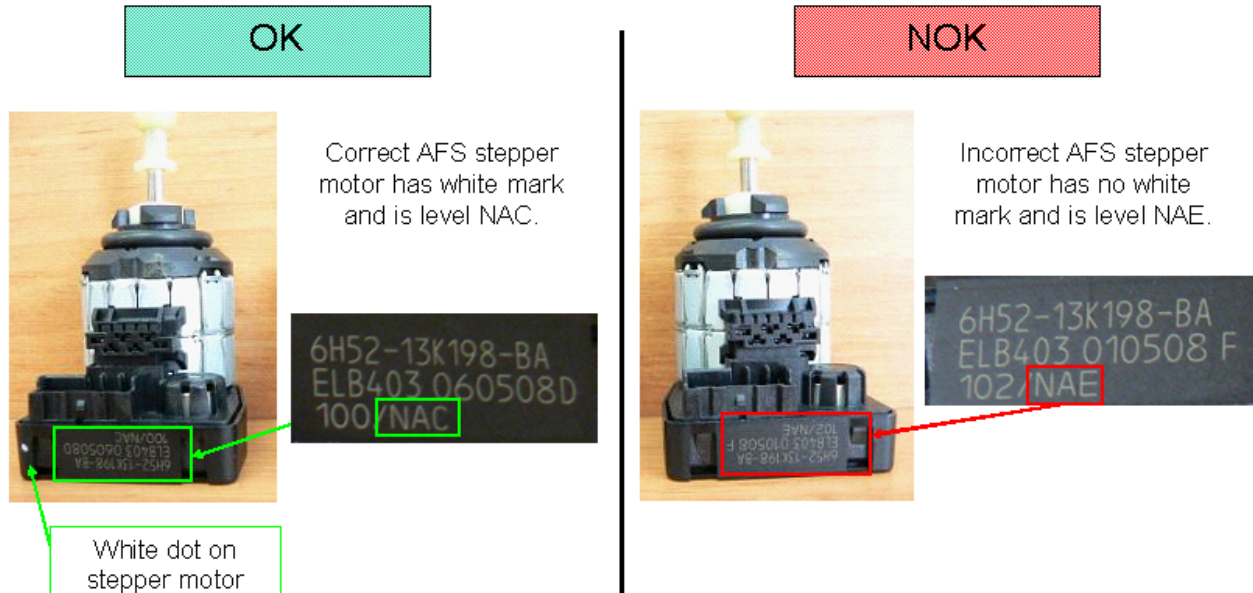
- Check the AFS stepper motor part details is at level NAC and has a white mark as per Figure 2 below

- If the headlamp(s) have a NAE level AFS stepper motor please replace the headlamp with latest level stock
- Inspect the new headlamp for correct level AFS stepper motor before fitting
- Read and clear DTCs from the Headlamp Control Module
